Contraflow Bike Lane and Bicycle Road in Chiang Mai Municipality by Nirandorn Potikanond **Chiang Mai Sunday Cycling Club**

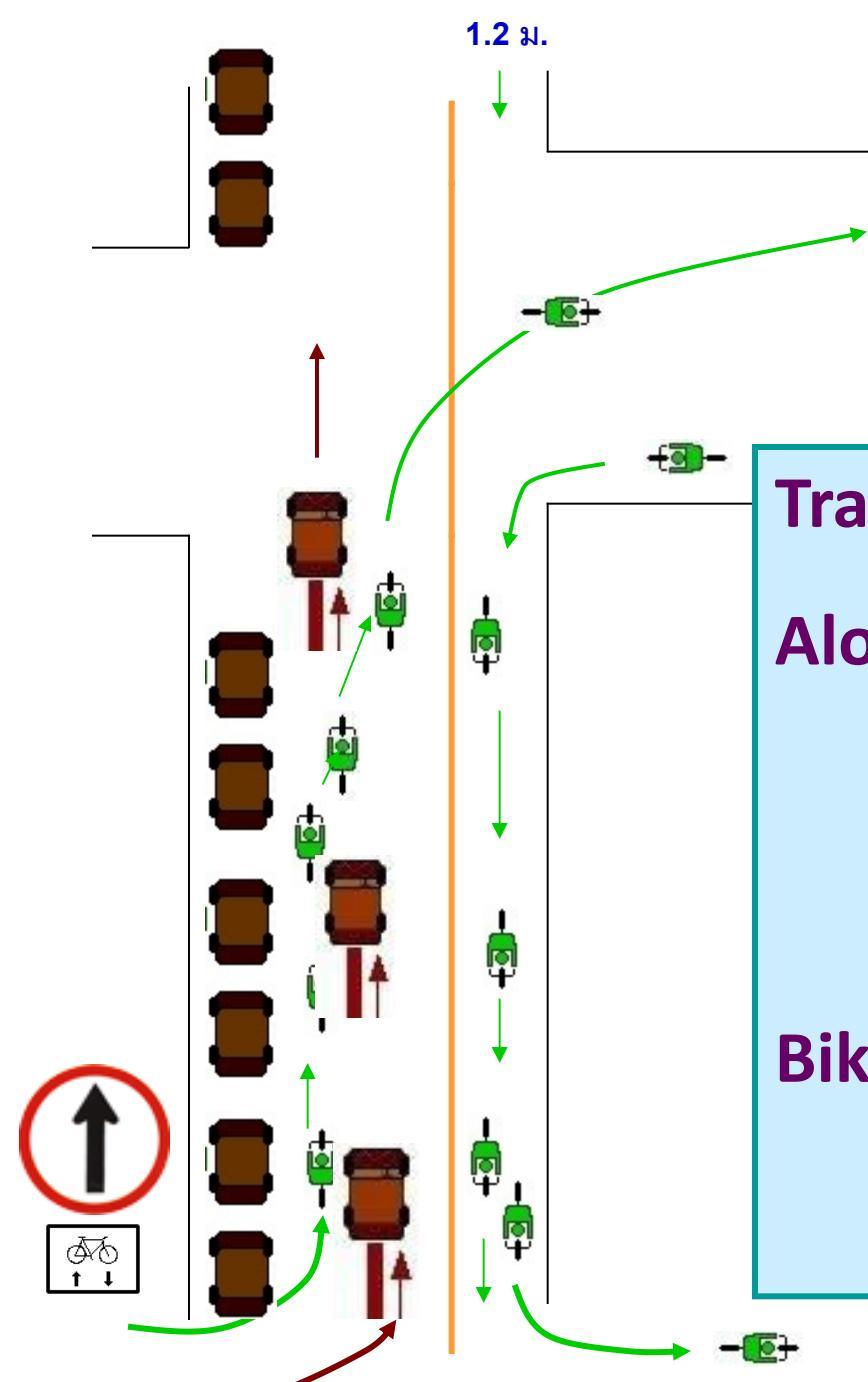
Traffic system: one-way roads with contraflow bike-lanes, 1.2 – 1.5 m wide on right-hand side

- 1. Forbidding the parking on right-hand side of four one-way roads. Introducing contra-flow bike-lanes to provide safety and convenience to cyclists. Certain sections of roads were implemented as a bicycle road with speed limit under 30 kph, one section was on a one-way road, another one on a two-way road.
- 2. Along three bike-routes on four roads, cyclists were allowed to commute two-way while motorized vehicles commuted one-way. Only on Ratcha Withi Road all vehicles were allowed to commute two-way.
- 3. One-way traffic for motorized vehicles but always two-way traffic for cyclists was applied (see next slide).
